WATERSHED WORK PLAN

WILLIS RIVER WATERSHED

Buckingham and Cumberland Counties, Virginia

August 1964

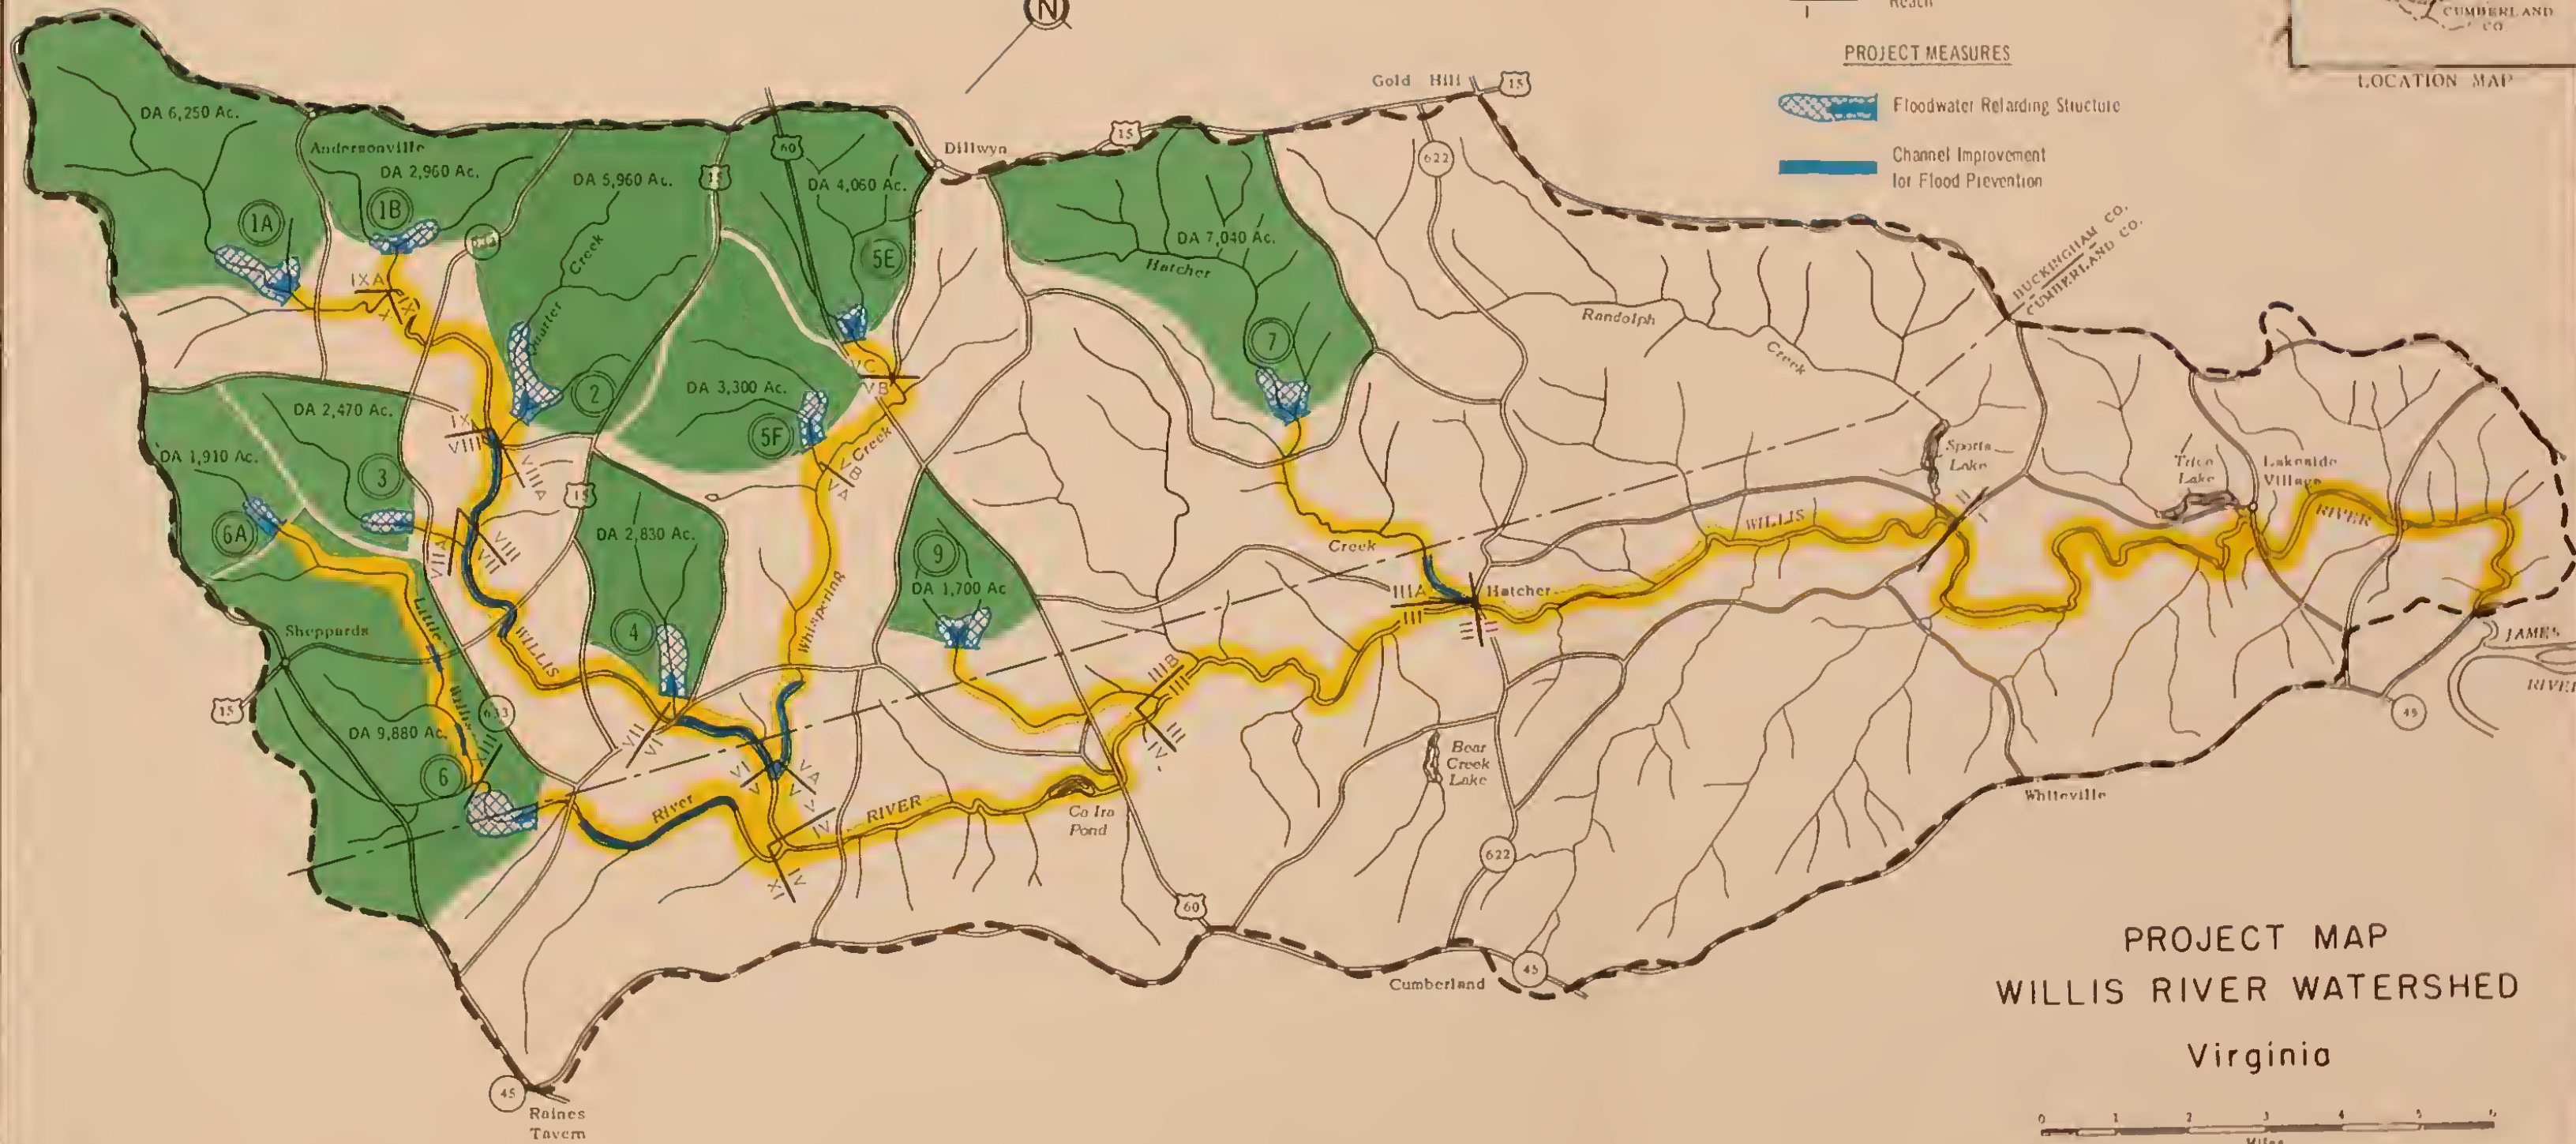
PROJECT MAP
WILLIS RIVER WATERSHED
Virginia

PROJECT MEASURES

- Floodwater Relarding Structure
- Channel Improvement for Flood Prevention
